Video Based Studies of Highway-Railroad Grade Crossings in the South Florida Railroad Corridor

Final Report

**Prepared for the Florida Department of Transportation
Rail Office
By The University of Florida
Transportation Research Center**

**Volume III
Video Based Studies of Highway-Railroad Grade Crossings
in the South Florida Railroad Corridor**

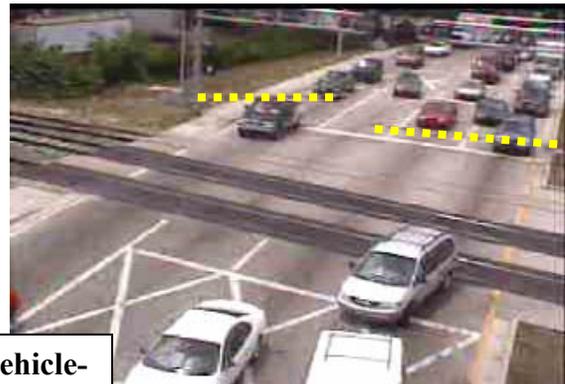
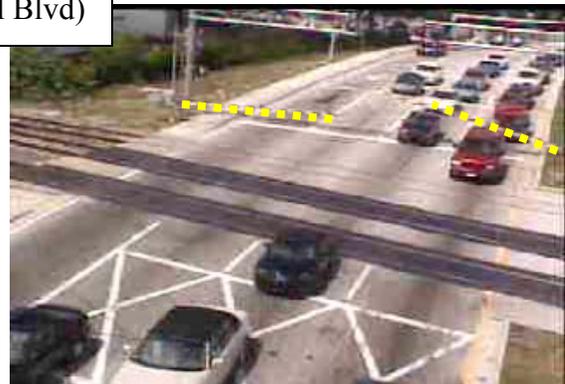
Photographs showing vehicle-gate contact.
(Both EB on Commercial Blvd)

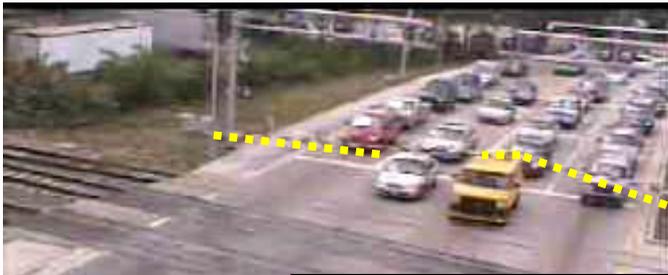
1. Vehicle breaks gate and enters crossing

Two vehicles pass through a breach in the gate caused by another vehicle (EB on Commercial Blvd.)

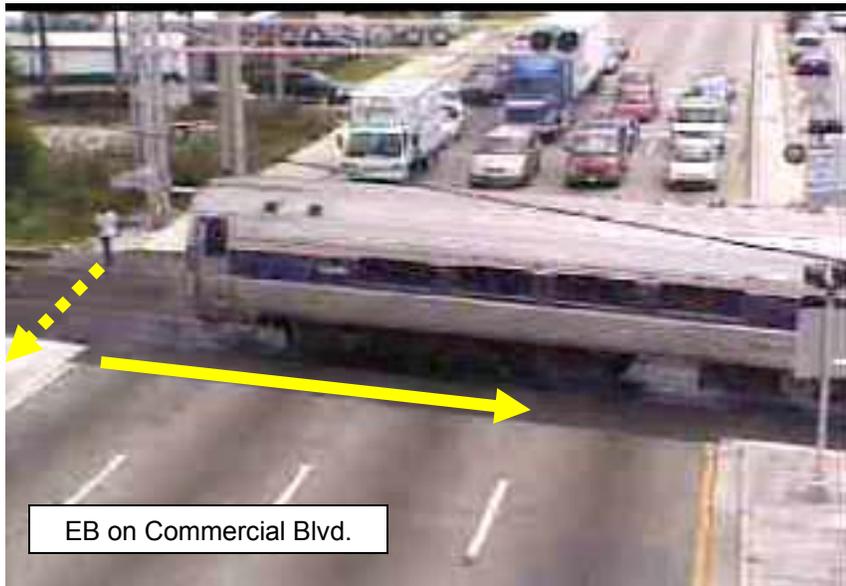
Pedestrian crosses behind train starting approximately 1 sec after train passage.

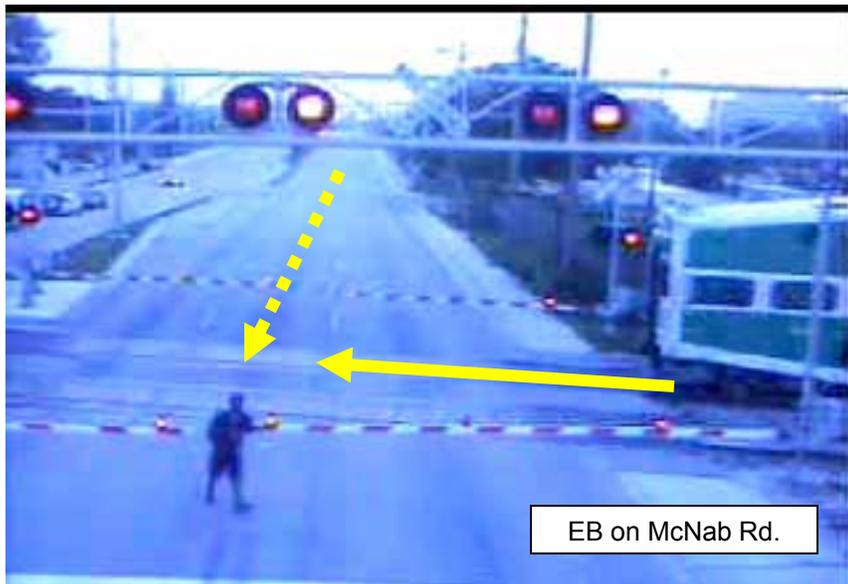
Pedestrian crosses between gates (running) and clears the track approximately 2.5 sec before train arrival.

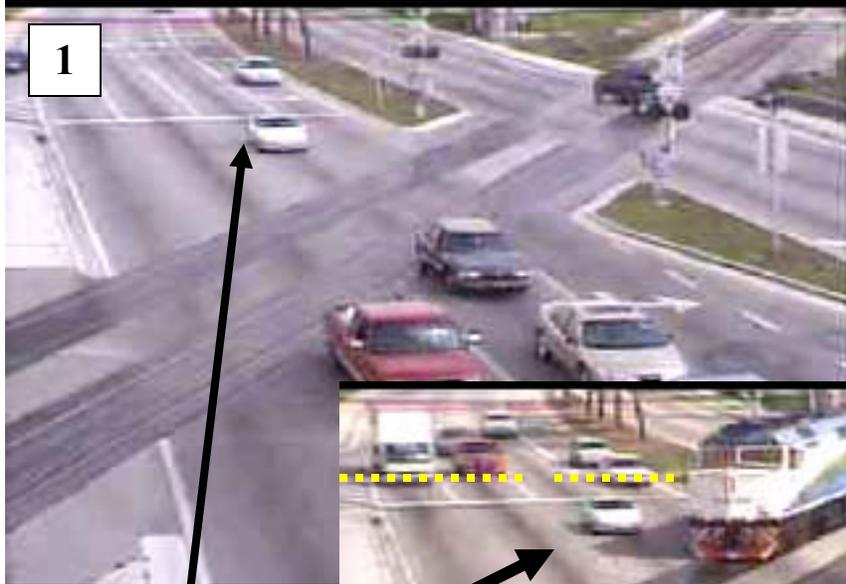
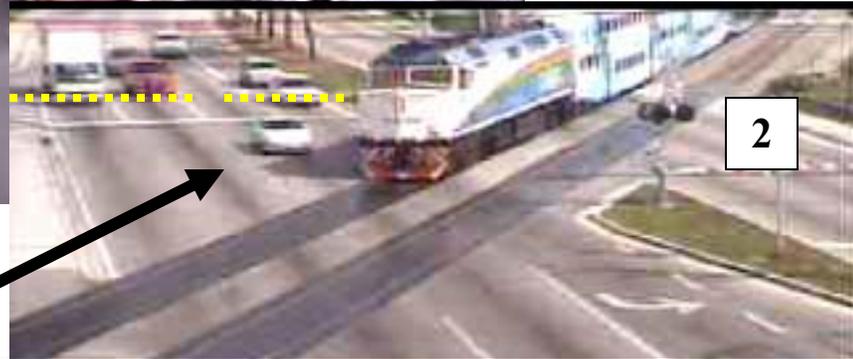
Here is a case in which motorists were trapped between the gate and the tracks while a train passed. In this case it is difficult to blame the motorist. Photo #1 shows that a vehicle stopped properly in advance of the tracks because of a downstream queue blockage. At that point, the warning gates were activated and descended behind the vehicle. Photo #2 shows the position of the vehicle when the train arrived. Photo #3, below, shows a large truck trapped between the gate and the train as a result of the same sequence of events. This is the southbound approach at Powerline Road.

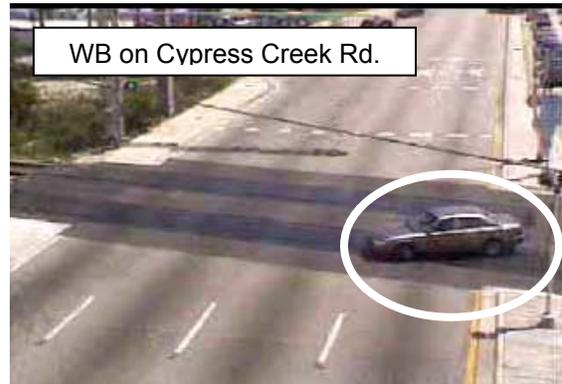
A total of 21 events of this type were observed and are included as a special case of anecdotal events. The photograph on this page illustrates a typical example of a U-Turn movement. The graphic chart on this page demonstrates that U-Turns within the crossing were well distributed among the various locations.
