Pullout Test on Barrier Reinforcing

March 2002

Submitted by: Marc Ansley

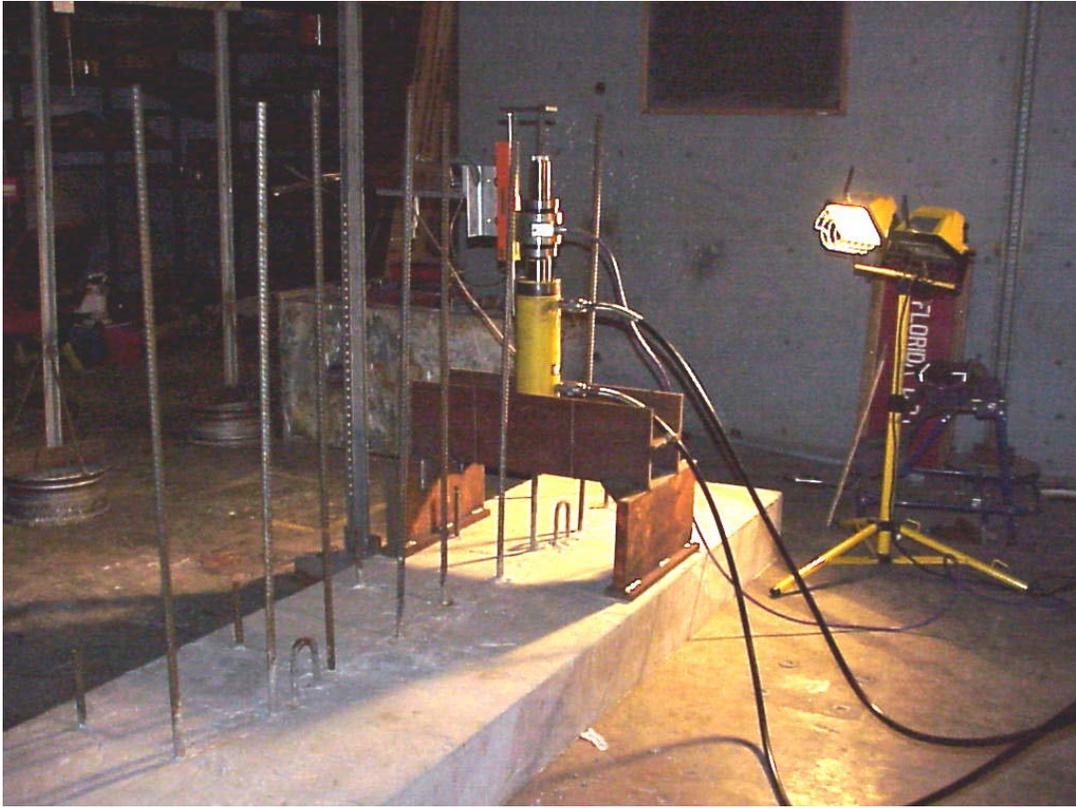
To provide for an unconfined condition the jacking load supports were placed 10 inches or more from the bar being tested. As can be seen from Figure 7 the support in the compression zone, for the barrier in bending, was placed adjacent to the projecting end of the U bar. This made the closest edge of that support 10 $\frac{3}{8}$ inches from the centerline of the bar while the other support edge was 12 $\frac{1}{8}$ inches from the center. The device was equipped with an inline load cell and deflection was measured at the end of the bar. The load cell and the deflection gage can be seen in Figure 7.
