Video Based Studies of Highway-Railroad Grade Crossings in the South Florida Railroad Corridor

Final Report

**Prepared for the Florida Department of Transportation
Rail Office
By The University of Florida
Transportation Research Center**

**Volume III
Video Based Studies of Highway-Railroad Grade Crossings
in the South Florida Railroad Corridor**

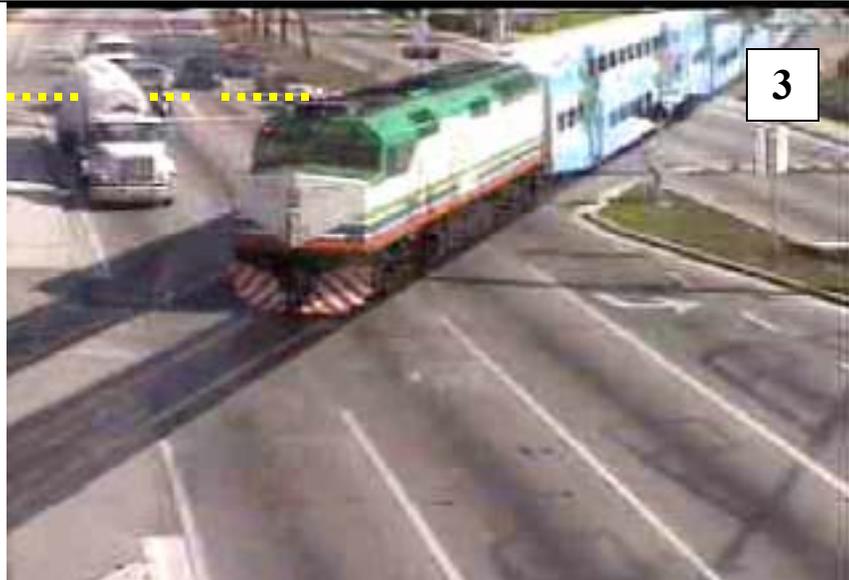
Here is a case in which motorists were trapped between the gate and the tracks while a train passed. In this case it is difficult to blame the motorist. Photo #1 shows that a vehicle stopped properly in advance of the tracks because of a downstream queue blockage. At that point, the warning gates were activated and descended behind the vehicle. Photo #2 shows the position of the vehicle when the train arrived. Photo #3, below, shows a large truck trapped between the gate and the train as a result of the same sequence of events. This is the southbound approach at Powerline Road.

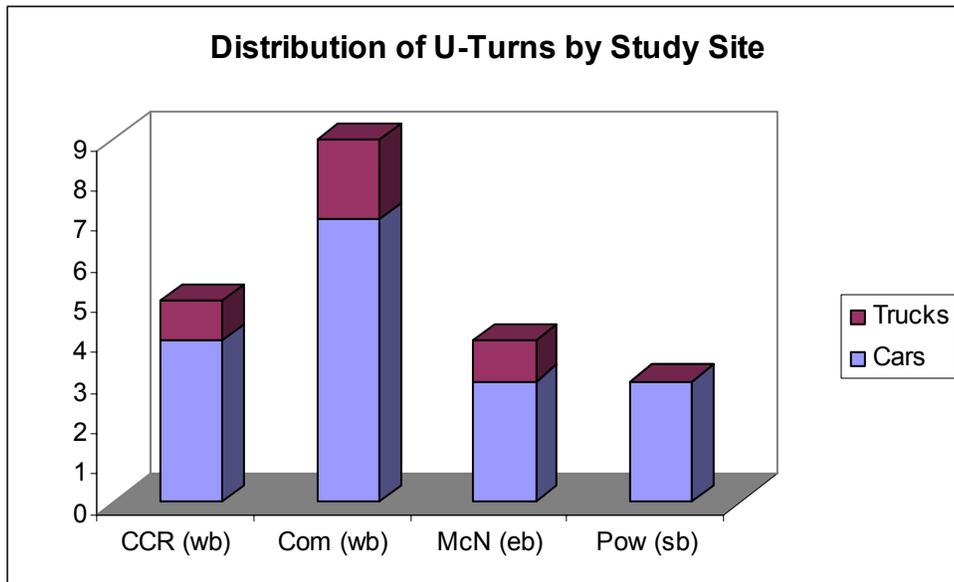
U-Turns Across the Tracks

A total of 21 events of this type were observed and are included as a special case of anecdotal events. The photograph on this page illustrates a typical example of a U-Turn movement. The graphic chart on this page demonstrates that U-Turns within the crossing were well distributed among the various locations.
